Cavitation Wear of the Blades of Francis Turbine

This work describes the harmful effects of cavitation wear upon the lifespan of Francis turbines. Furthermore, there is a concrete example of regeneration of the blades damaged by cavitation erosion.

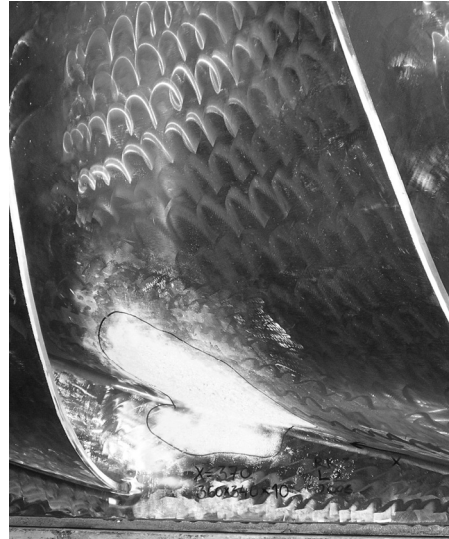
- Cavitation damage of 0.5 mm in depth at the entrance of the working wheel, on the left side of all blades and in the inter-blade spaces on the lower wreath.
- Initial cavitation of 0.5 mm in depth and cavities of 1-2 mm in perimeter and more than 0.5 mm in depth on the left side of the blades No. 4, 5, 6, 7, 8, 9, 11 and 13.
- The zones with cavitation damage of considerable depth (up to 10 mm) and extent were seen on the back of the blades. This refers to the blade No. 2 (the depth of cavitation damage up to 10 mm), No. 3 (the depth of cavitation damage up to 8 mm), No. 10 (the depth of cavitation damage up to 7 mm), and No. 12 (the depth of cavitation damage up to 4 mm).

Picture 4. Cavitational damage on the back of the blade No. 2

All the places with cavitation damage of greater depths (up to 12 mm) and extents, noticed on the blades No. 2, 3, 10 and 12, were ground down to healthy material and prepared for built-up welding.

After the shaping, the ground parts were welded. They were subjected to built-up welding by the electrode Piva 29/9 R (29% Cr and 9% Ni), perimeter φ2.5 mm and φ3.25 mm, by ARC procedure without preheating.

Built-up welding was done at 1-2 mm above the surface of the blades. This layer was ground and polished down to the specified geometry and surface quality (R_a ≤ 16 μm).

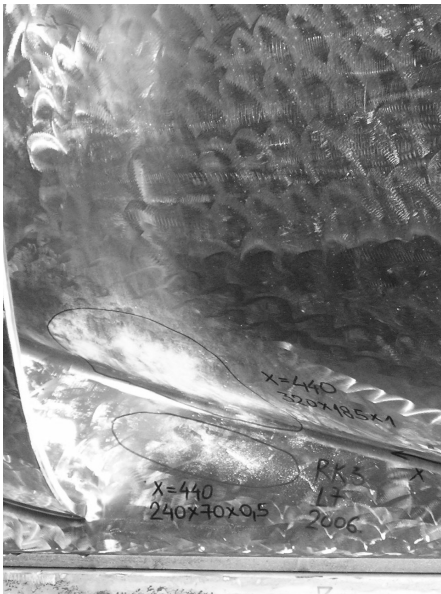
Picture 2. Cavitational damage on the back of the blade No. 7

welding. This was done with the blades No. 4, 5, 6, 7, 8, 9, 11 and 13.

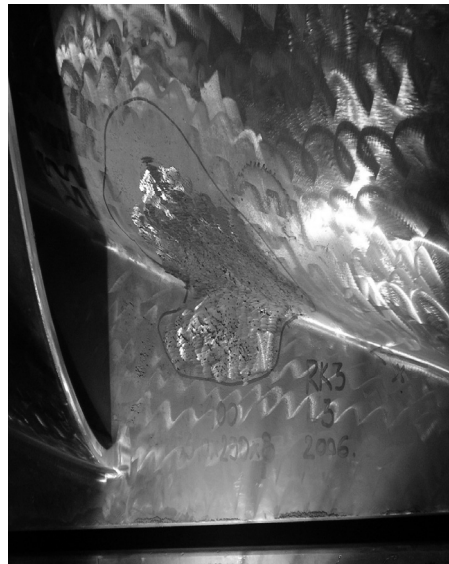
Picture 5. Cavitational damage on the back of the blade No. 3

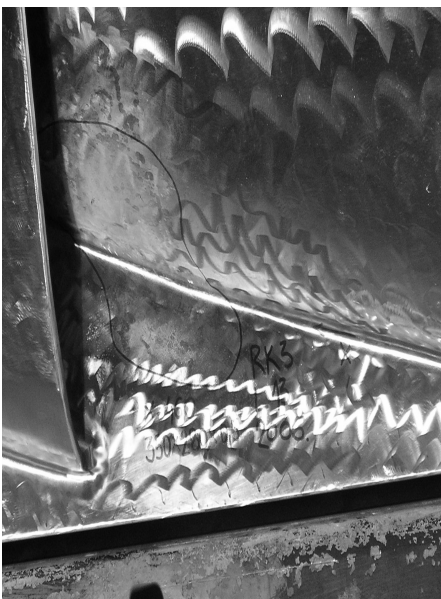
Picture 3. Cavitational damage on the back of the blade No. 13

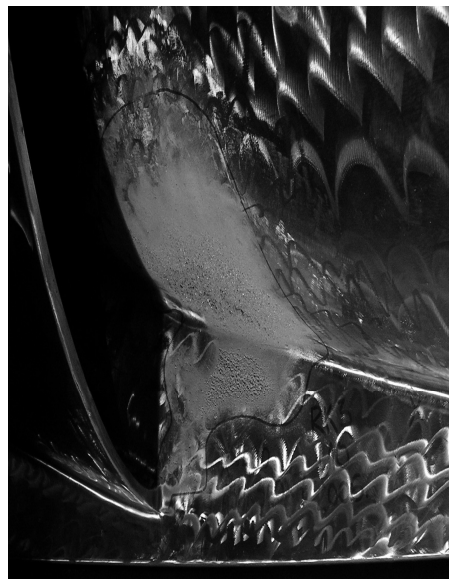
Picture 6. Cavitational damage on the back of the blade No. 10

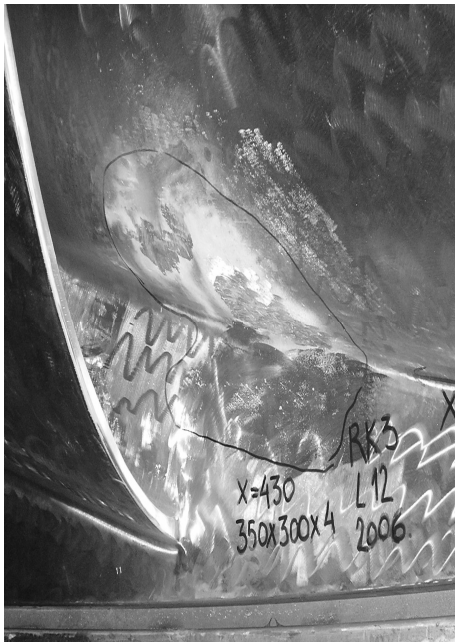
Picture 7. Cavitation damage on the back of the blade No. 12
