Wear and Degradation Modes in Selected Vehicle Tribosystems

G. Pantazopoulos^a, A. Tsolakis^b, P. Psyllaki^b, A. Vazdirvanidis^a

^aELKEME Hellenic Research Centre for Metals S.A., 252 Pireaus Str., 17778 Athens, Greece,

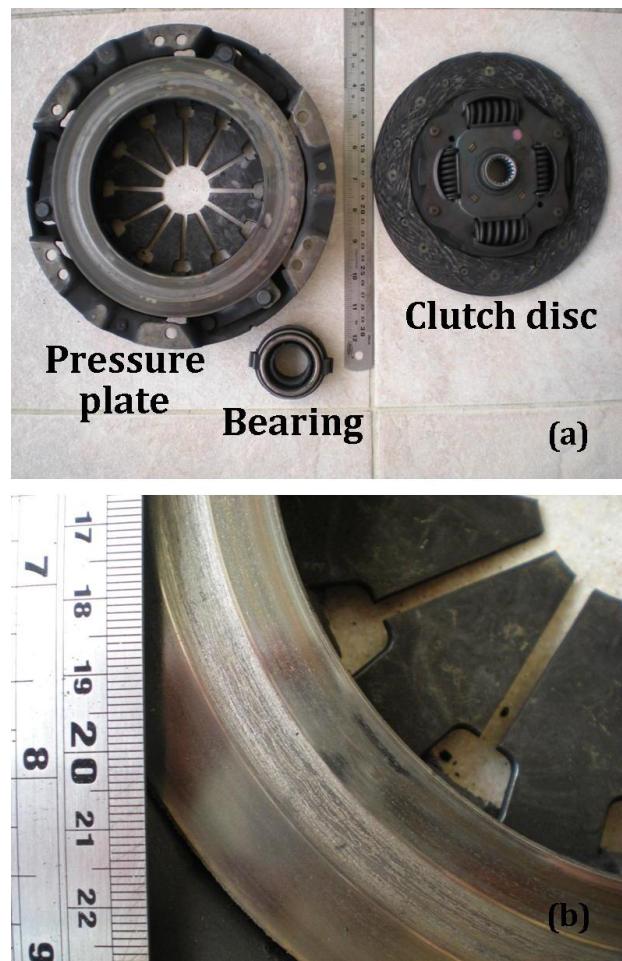
Fig. 1. Macro-graph of the failed (a) Clutch assembly, (b) Metallic pressure plate (detail).

The premature failure of the clutch assembly concerned its unexpected lost of function after ~40.000 km of service that necessitated its immediate replacement. A general remark in the case of the retrieved metallic pressure plate is that its entire surface has been affected during service. Surface areas, which had not been in contact to the clutch disk, exhibited discoloration, indicative of local oxidation (Fig. 1b). Even if these areas are not actually parts of the tribocouple, are affected by the heat dissipation from their neighbouring heavily loaded contact area. On the contact area, a ~10 mm-wide wear track was formed (Figs. 1b, 3a and 4), exhibiting a surface relief consisting of a sequence of deep valleys and crests (Fig. 3b). The stereo-microscopic observations of the wear track (Figs. 3a, 3c), as well as the optical-microscopic ones (Fig. 3d), indicated severe dragging and deep grooving along the sliding direction, as the main wear modes accompanied by micropolishing and microcutting. Such mechanisms are common in tool and bearing materials, as reported in the relevant literature [3-6]. The oblong deep grooves observed are consistent with the roughness measurements at various locations along the wear track (Fig. 3b), that allowed the determination of their mean dimensions as ~3 mm in width and ~0,2 mm in depth.

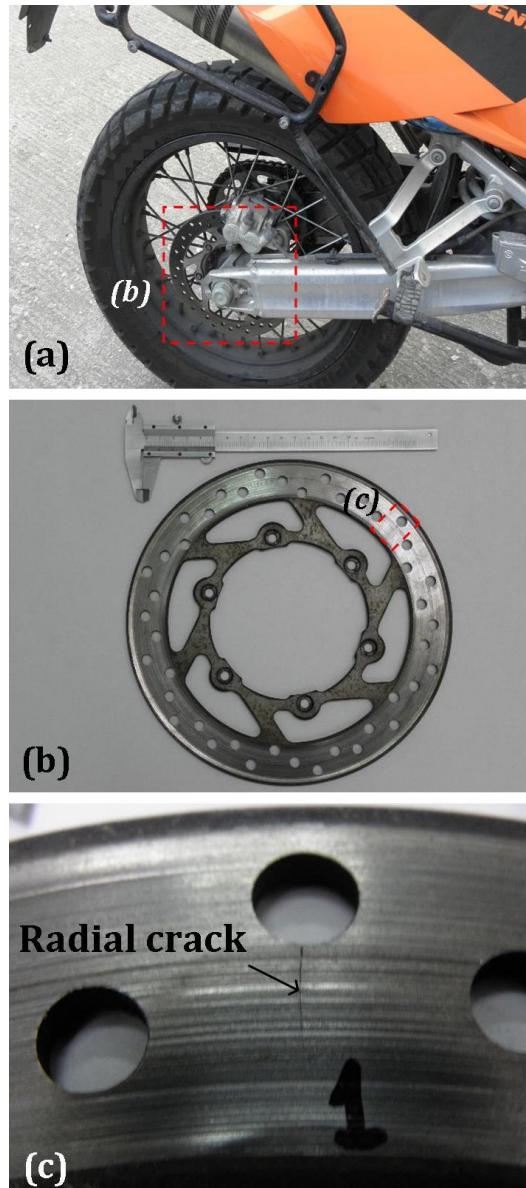
Fig. 2. (a) Motorcycle braking assembly, (b) Metallic brake disk failed, (c) Detail of (b).

The present case concerns the premature failure of a brake disk operating in a high performance motorcycle. The component under study is a single body, comprised however of two distinct parts, like all similar components: the first (bridge) attaches firmly the component on the wheel and transmits the braking torque to it; the second (flange) is the main part of the component that participates in the tribosystem being in contact with the consumable part during the braking process. To address the issue of thermal loads developed during their operation, the flanges carry ventilation holes of various shapes and arrangements [11]. As already shown in Fig. 2b, the ventilation holes of this particular disk are arranged in a 3-2-2 pattern, repeated 6 times in total. Despite the fact that during periodic maintenance, the disk thickness reduction was within acceptable levels ($\sim 0,6$ mm < 1,0 mm according to the manufacturer's specification), radial cracks emanating only from the outmost ventilation holes were identified (Fig. 8). Similar failure findings have also been reported and studied recently [12].

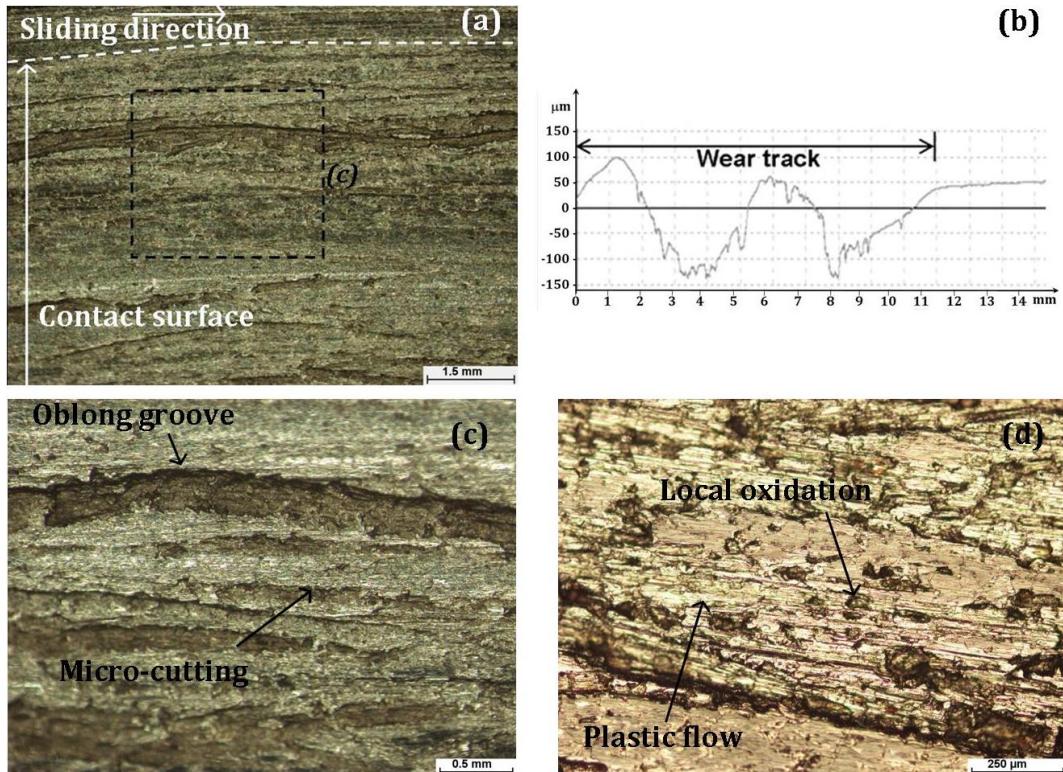
Fig. 3. Characteristics of the worn surface of the pressure plate: (a) Top view stereo-micrograph, (b) Surface profile across the entire wear track, (c) Stereo- and (d) Optical-micrographs showing details of the wear mechanisms.

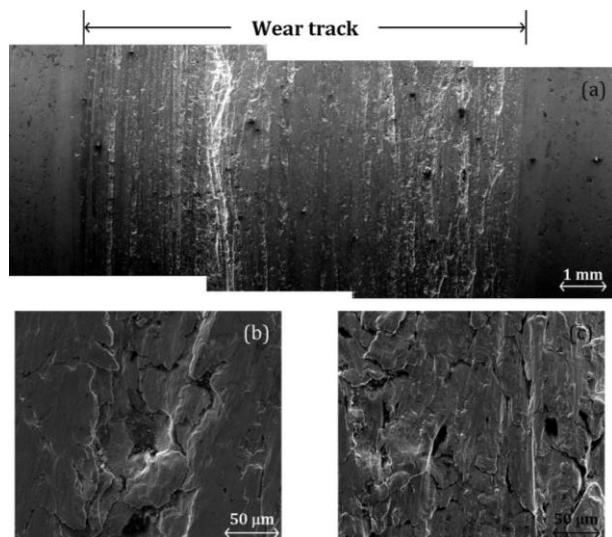
Fig. 4. SEM micrographs of (a) the wear track formed on the contact area and (b) and (c) magnifications of characteristic areas within it.

Further SEM observations within the wear track showed a random presence of voids, with average dimensions of 30 μm, as well as severe plastic flow of the metal along the sliding direction (Fig. 4). The presence of voids suggests the occurrence of prior ductile tearing of the surface under high stress state followed by crack opening and growth, leading to smearing under the operation conditions of the tribosystem.

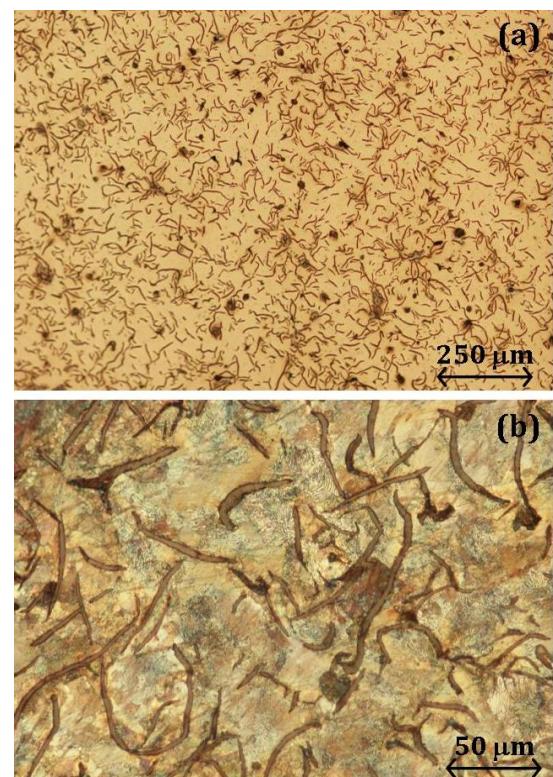
Fig. 5. (a) Optical micrographs of the pressure plate initial microstructure and (b) magnification of (a).

iron, with graphite flakes dispersed in a ferrite-pearlite matrix (Fig. 5). The microhardness values corresponding to this microstructure varied from 220 to 240 HV1, with the higher ones measured underneath the worn surface, indicating possible associated work hardening due to plastic deformation imposed on a thin surface layer of the pressure plate.

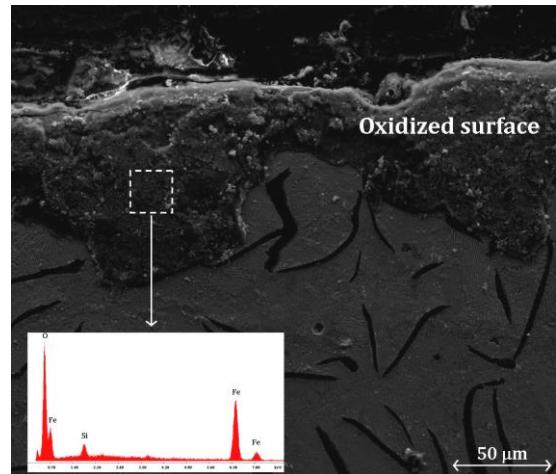
SEM observations combined with EDS analysis on cross-sections revealed also in-depth oxidation of the metallic surface (Fig. 6), due to heat evolution during sliding friction. Thermo-mechanical numerical simulations via finite element analysis of similar clutch plates operating under dry sliding conditions indicated temperature raises in the order of 150-250 °C, after 10 repeated engagements [7,8]. In the particular case presented in this study, such a temperature increase can render the metallic plate more prone to oxidation, whilst the expansion of the oxidation layer could be attributed to even higher temperature increase associated to more severe operational conditions, probably applied accidentally. This surface oxide layer due to its brittleness enables flaking and spalling mechanisms, which in turn amplify material removal from these specific areas, creating secondary grooves of approximately the same dimensions. The morphology and the dimensions of the oxidized areas and the grooves advocates for these being consecutive instants of a complementary wear micro-mechanism of the friction surface that acted in synergy to the overall surface deterioration: under loading which leads to overheating, the metallic surface is locally oxidized with the oxidation advancing preferentially within the ferrite-pearlite matrix [2]. During sliding, the shear stresses developed in the brittle oxide result in cracking of the oxide layer followed by its removal from the metallic plate, leaving surface pits and grooves.

Fig. 6. Near contact surface SEM micrograph of cross-section and corresponding EDS analysis on the area marked, indicating local in-depth oxidation.

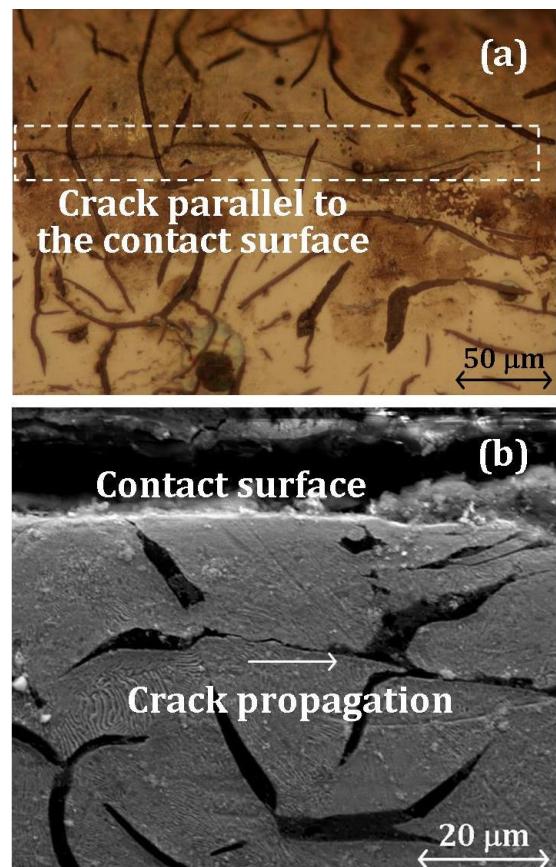
Microscopic observation of cross-sections transverse to the contact area revealed also that the pressure plate degradation is not limited only to surface phenomena, but is in-depth extended. In Fig. 7, crack initiation at graphite flakes edges [9] well below the worn surface and its propagation within the ferrite-pearlite matrix in a direction parallel to the contact surface is clearly observed, not only in the higher-magnification SEM micrograph but is also

evident in the optical one. The depth, at which these cracks are observed, was in all cases of the order of 20-30 µm, corresponding almost precisely to the depth at which maximum shear stress was established for the particular operating conditions and system configuration, according to Hertz contact stress theory [5].

Fig. 7. (a) Optical and (b) SEM micrographs of cross-sections indicating crack propagation parallel to the contact surface within the metallic matrix.

revealed the evolution of subsurface cracks propagating parallel to the worn surface during sliding and severe local oxidation of the metallic surface. The graphite flakes' morphology facilitates crack initiation and propagation within the pearlite matrix. Preventive maintenance, scheduled periodically or just after an overload incident is suggested as the main measure to manage safety risks.

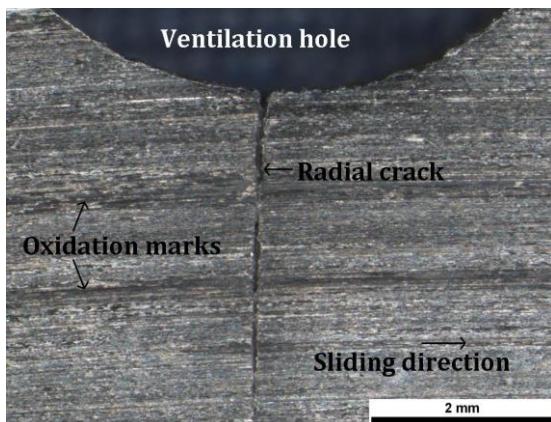
Fig. 8. Stereo-micrograph of failed area, depicting a radial crack emanating from a ventilation hole.

On the contact surface of the flange, clear traces of ploughing can be recognised corresponding to abrasive wear mechanisms due to the sliding contact of the ceramic particles reinforcement of the composite brake pad onto the stainless steel disk (Figs. 8, 10a). Isolated regions of severe

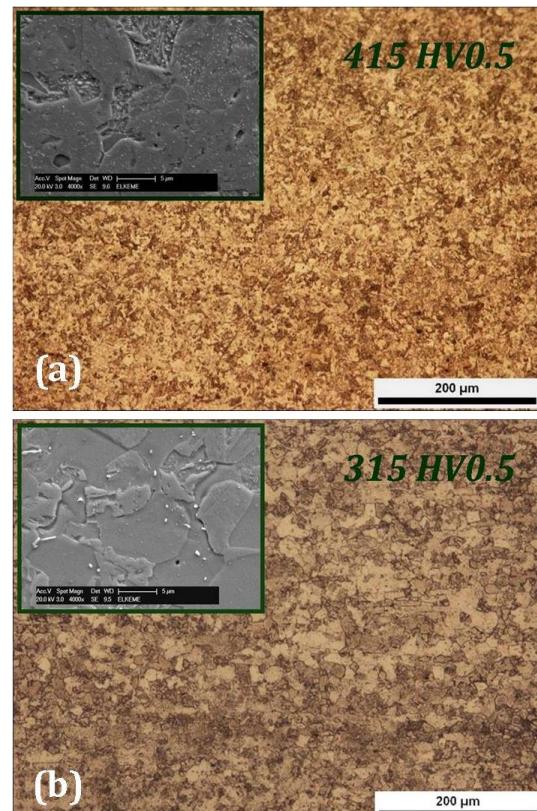
Optical and SEM evaluation of cross-sections of the brake disk showed a fine-grained (~ 10 μm) microstructure on both bridge and flange areas. More specifically the flange area (Fig. 9a), which constitutes the brake area in contact to the brake pad consisted of a hardened and tempered martensitic microstructure of a microhardness of 415 HV_{0,5} almost 100 HV_{0,5} higher than that of the bridge area (Fig. 9b).

Fig. 9. Microstructure evolution of the stainless steel brake disk: (a) hardened and tempered structure of the flange area, (b) initial structure of the bridge area.

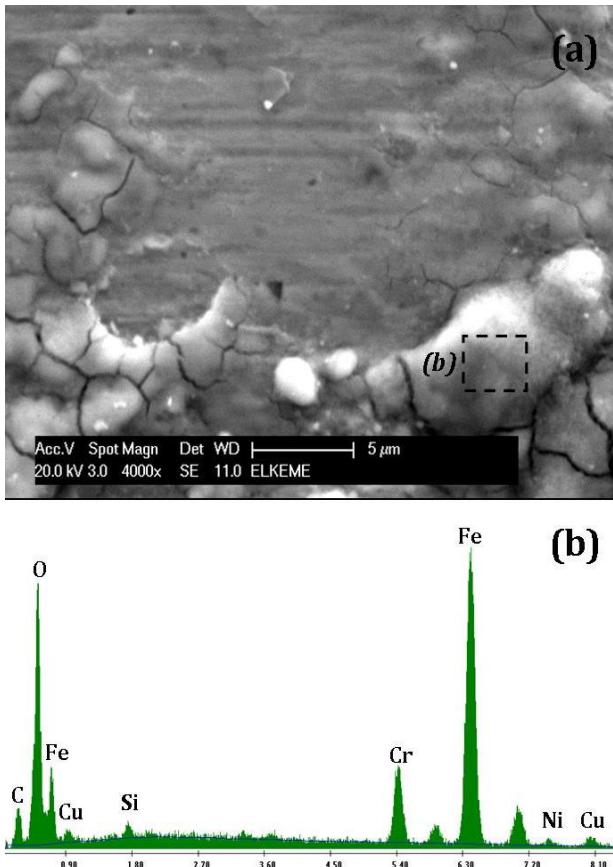
oxidation of the stainless steel were identified (Figs. 10a, 10b) indicative of local temperature raise above 600 °C during braking. 3-D optical profilometry measurements along the direction perpendicular to the wear track (Fig. 11a) determined the roughness characteristic parameters as follows: Ra=4.27 μm, Rq=4.93 μm, Rz=18.46 μm and Rt=18.83 μm. The almost linear shape of the respective Abbott-Firestone curve (Fig. 11b) demonstrated the constant wear rate during sliding, free from abnormal events.

Fig. 10. (a) SEM micrograph of the flange contact surface indicating abrasive wear mechanism and isolated oxidation regions, (b) EDS analysis of the area marked in (a).

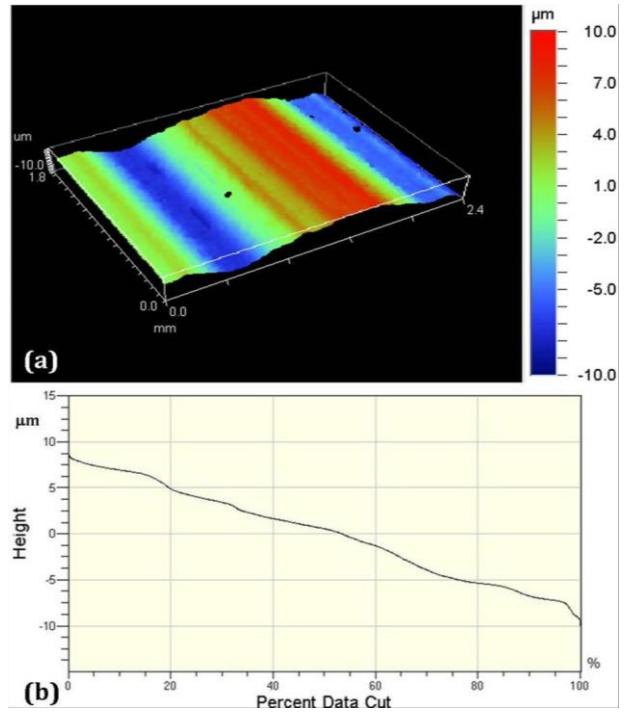
Fig. 11. (a) 3-D topography of the flange contact surface, (b) Respective Abbott-Firestone curve.

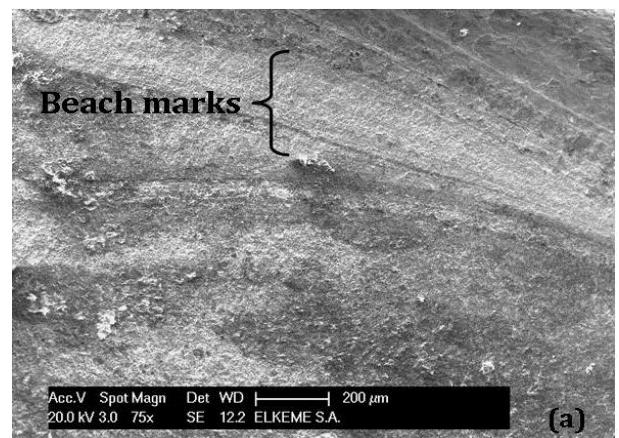
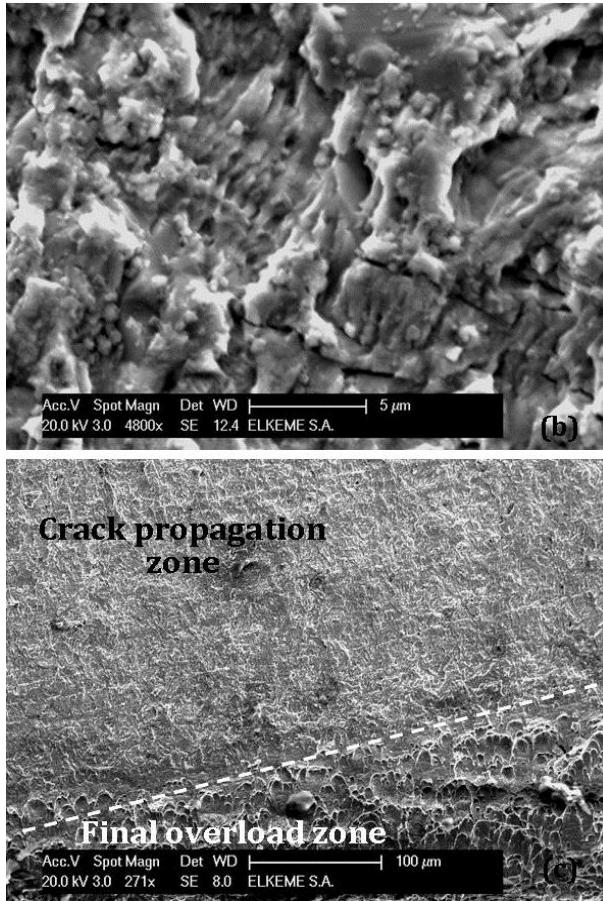
A specimen including the radial crack, as well as a significant non-affected area around it, was sectioned from the flange body, in order to observe the features of the created crack's fracture surface via SEM. In this respect, the radial non-affected area from the crack tip to the edge of the specimen was manually separated into two pieces by overloading. Fractographic evaluation of the conjugate surfaces indicated fatigue as the mechanism responsible for the crack initiation and propagation.

Fig. 12a presents fracture area adjacent to the ventilation hole. The presence of crack-arrestment marks, commonly known as beach marks, having occurred from intermittent loading is clear evidence of fatigue crack propagation via a flat and smooth front. Fig. 12b shows the fracture characteristics of the area adjacent to the crack tip. The striation-like pattern observed is typical signature of fatigue related to micro-plasticity processes at the crack tip (sharpening/blunting), and also depicts the local crack advancement per load cycle. Finally, Fig. 12c presents the area at the boundary between the crack propagation and post-crack-created overloaded area. The overloaded area consists of ductile shear (non-equiaxed) dimples coming from final ductile shear rupture.

Fig. 12. Characteristic features on selected areas of the fracture surface: (a) Close to the ventilation hole, (b) Close to the crack tip, (c) At the interface between fatigue crack propagation and final overload area.

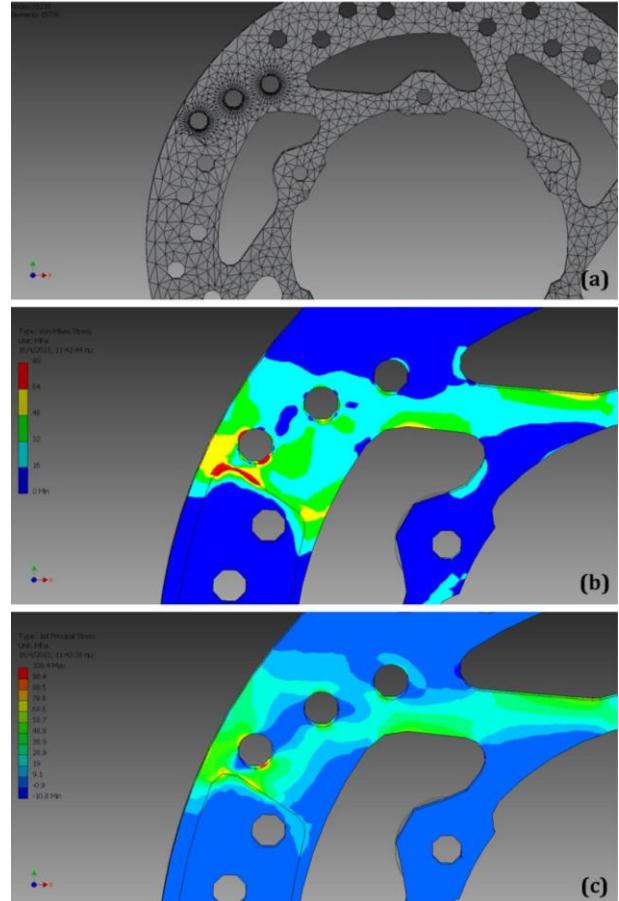
In order to address issues of crack initiation location only at the outermost ventilation hole, Finite Element Analysis was employed. In this perspective, preliminary simulations were performed for the "extreme" case of emergency braking conditions. In this case, the thermal effects can be considered negligible, so that only the mechanical (and not the entire "real" thermo-mechanical) effects can be taken into account. The whole brake disk was simulated by a global mesh of tetrahedral curved elements, more concentrated around the ventilation holes (Fig. 13a). For the calculations, a clockwise disk rotation was imposed, inducing a counter-clockwise friction force radial distribution. This friction force distribution was calculated based on "uniform pressure" theory [13]. The disk was assumed to be free of any prior mechanical and thermal loading. In the particular case of emergency braking conditions, under 35 bar pressure and an average friction coefficient of 0.53, as provided by the disk manufacturer, both von Mises and first principle stresses were calculated (Figs. 13b, 13c).

Fig. 13. Numerical simulation using Finite Element Analysis: (a) Global mesh of tetrahedral elements used, (b) Von Mises and (c) first principal, stress distribution contours.

It can be clearly seen that, indeed, the mechanical stresses present their maximum values at the outermost ventilation hole, where crack initiation and propagation was experimentally observed. More precisely, the maximum equivalent Von Mises and first principal stress found to be 80 and 108,4 MPa, respectively.
