Investigation of Nanostructured Thin Films Adhesion used to Improve Tribological Characteristics of Hip Prostheses

ABSTRACT

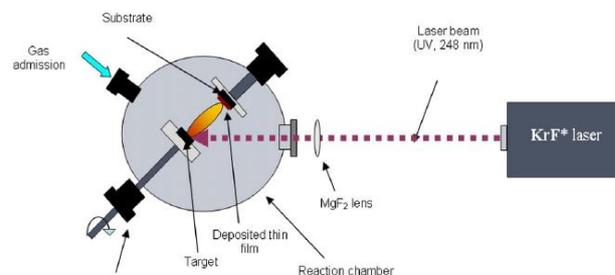
Fig. 1. PLD experimental scheme.

PLD experiments were conducted using a KrF* excimer source ($\lambda = 248 \text{ nm}$, $\tau_{FWHM} = 25 \text{ ns}$, $\nu = 10 \text{ Hz}$) – Fig. 1, running at a repetition frequency of 10 Hz. The laser beam was incident at 45° on the target surface.

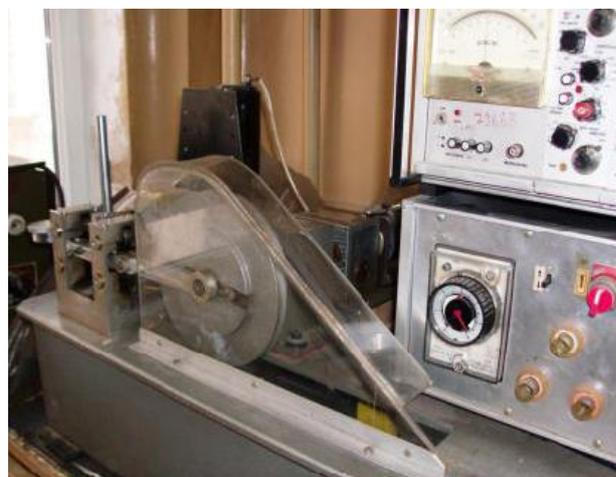
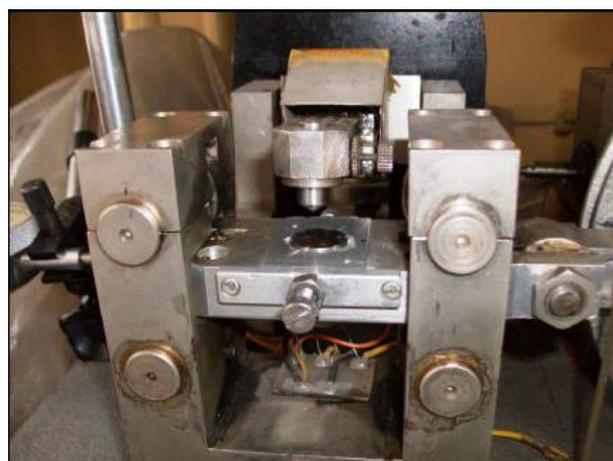
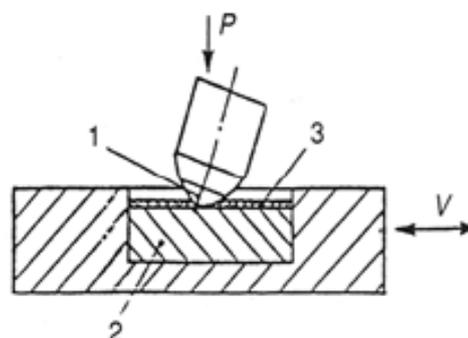
Fig. 2. (a) Overview of scratch facilities with a diamond spherical segment. (b) View of the scratching thimble. (c) Functional scheme: 1 – natural diamond spherical segment; 2 – sample of tested material; 3 – lubricant.

In our experiments, adhesion strength of TiN layers was analysed by making scratches with the tester presented in Fig. 2, with a spherical diamond tip, at loads of 2.5 N, 5 N, 10 N, 20 N, 40 N, 80 and 125 N.

Support plate of the testing sample (2) has an oscillatory motion. The sample is loaded by a spherical segment of diamond, with a radius of 2 mm (1). The plate is coated with a thin layer (3) of lubricant (bovine serum) during the test. Use of a friction thimble involving natural diamond against the material to be investigated, allows to considerably simplify the testing devices, the movement being sliding motion.

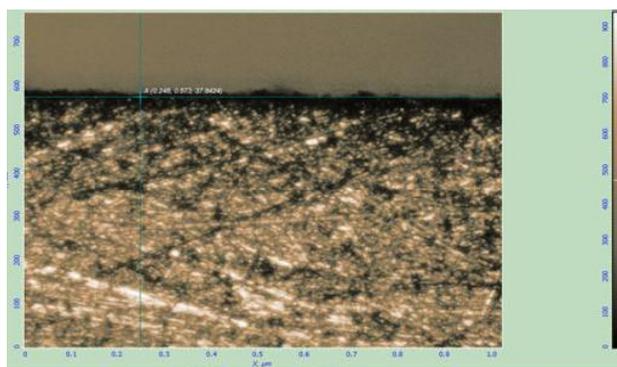
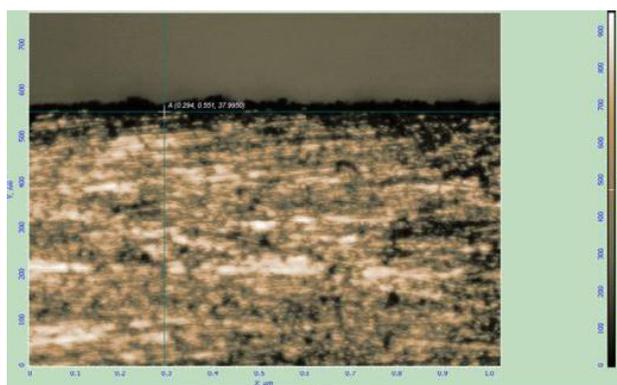
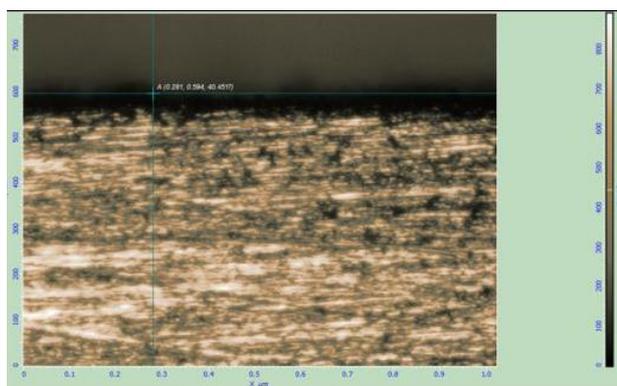
Fig. 4. AFM study of cross sections of stainless steel samples coated with TiN at (a) 5000 pulses, (b) 10000 pulses and (c) 20000 pulses.

We tried to determine the thickness of the TiN layers deposited at 5000, 10000 and 20000 pulses by scanning its surfaces with AFM (few examples in Fig. 4).

(a) 5000 pls₁₀ → 1.5 μm

(b) 10000 pls₁ → 1.9 μm

(c) 20000 pls₉ → 4.1 μm

- by OM: 1,1 μm for 5000 pulses and 1,62 μm for 20000 pulses;
- by AFM: 1,67 μm for 5000 pulses, 2,11 μm for 10000 pulses and 2,72 μm for 20000 pulses;

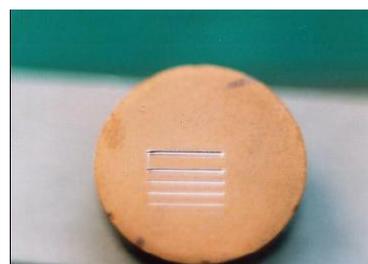
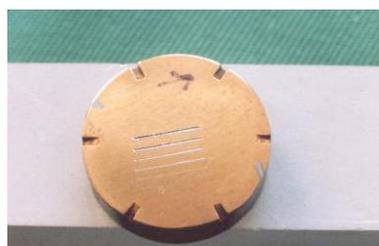
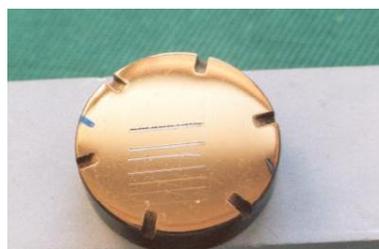
Fig. 5. Macroscopic image of the SS 316L steel sample coated with TiN at (a) 5000 pulses, (b) 10000 pulses and (c) pulses after scratch tests

All TiN layers deposited at 5000, 10000, 20000 pulses were scratch tested (Fig. 5) and, subsequently, surfaces of steel SS316L disks coated with TiN were macroscopically and microscopically studied.

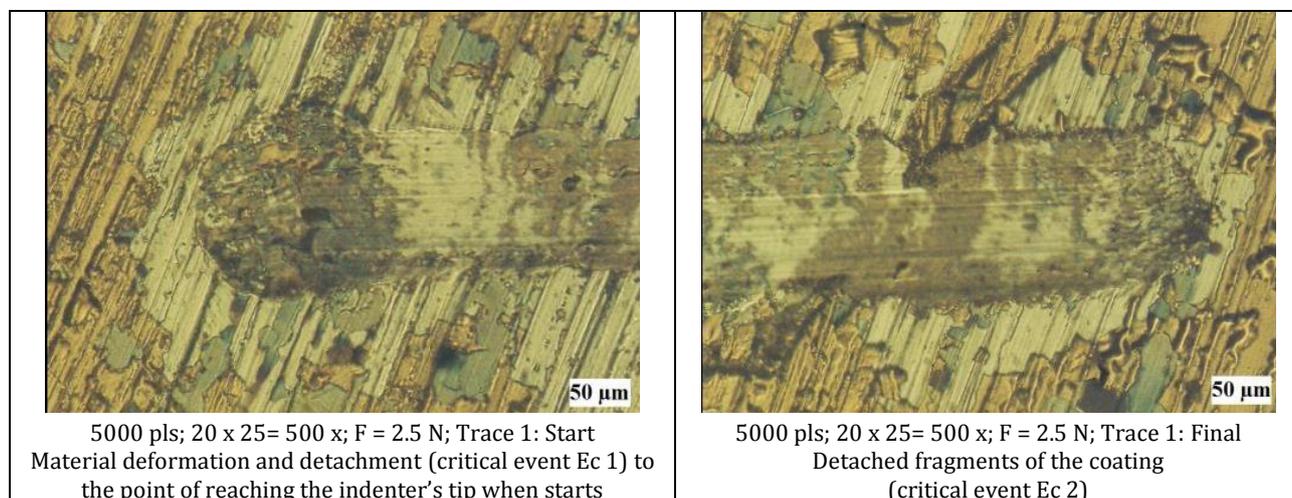
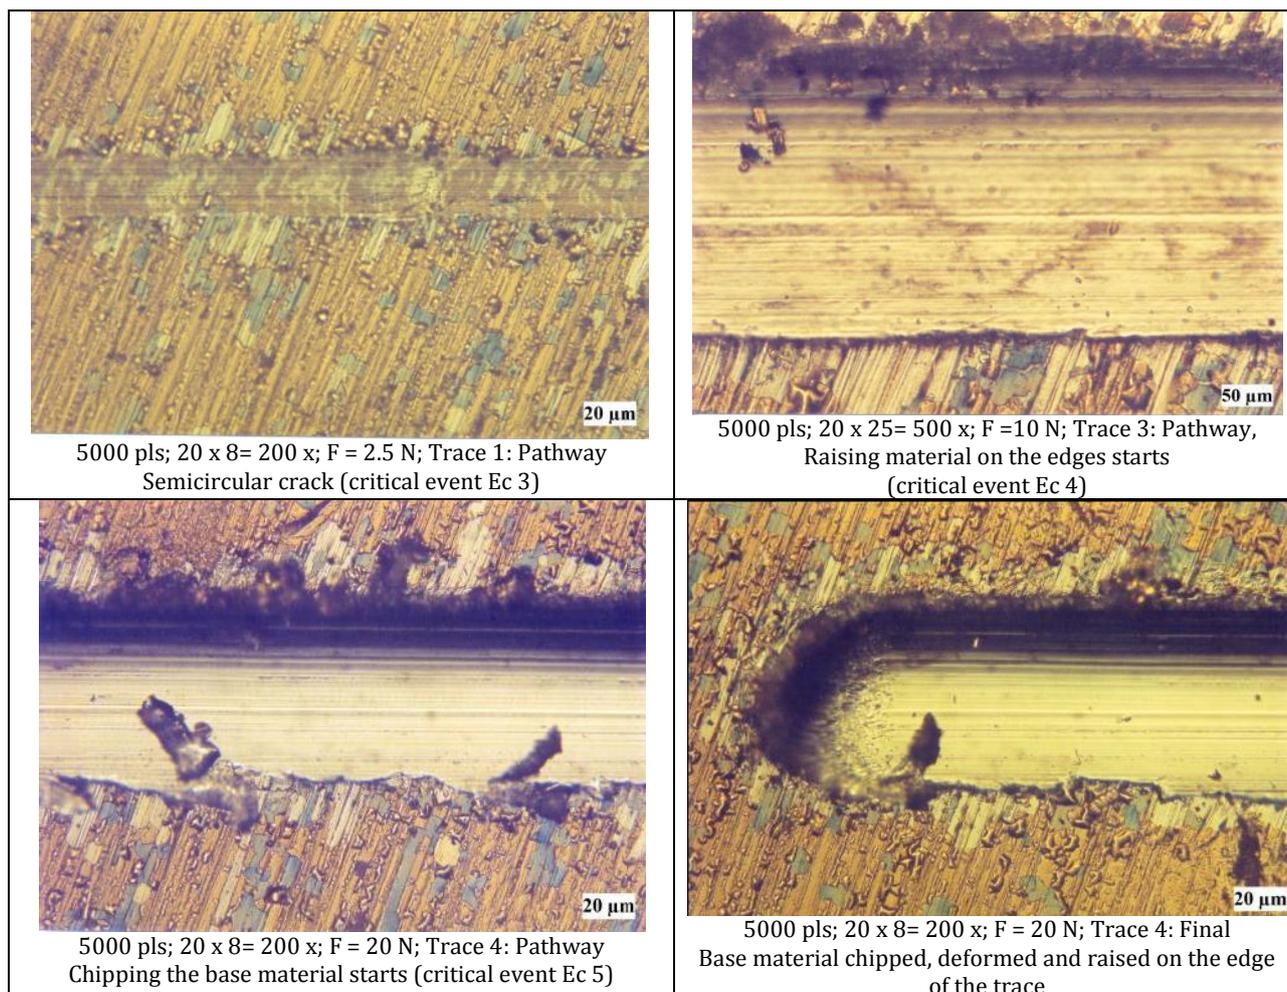
Table 3. Microscopic images of the main critical events appeared after scratch tests on the surfaces of 5000 pulses sample.

5000 pls; 20 x 25= 500 x; F = 2.5 N; Trace 1: Start
Material deformation and detachment (critical event Ec 1) to the point of reaching the indenter's tip when starts

5000 pls; 20 x 25= 500 x; F = 2.5 N; Trace 1: Final
Detached fragments of the coating (critical event Ec 2)

(Ec1), detached fragments of the coating (Ec2), semicircular cracks of the coating (Ec3), raising material on the edges (Ec4), chipping the base material (Ec5) and oxidation (Ec6). In Table 2 there is a summary of information about the main features of scratches made on the surface of TiN coating deposited with 5000 pulses after the scratch test. It is about the critical events that occur in certain moments of critical forces action, with values of 2.5 N, 5 N, 10 N, 20 N, 40 N and 80 N. A part of the microscopic images of the traces appeared after the scratch tests performed, i.e. those that correspond to the critical events are presented in Table 3.

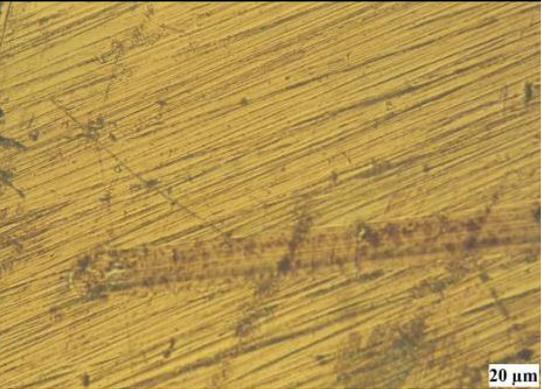
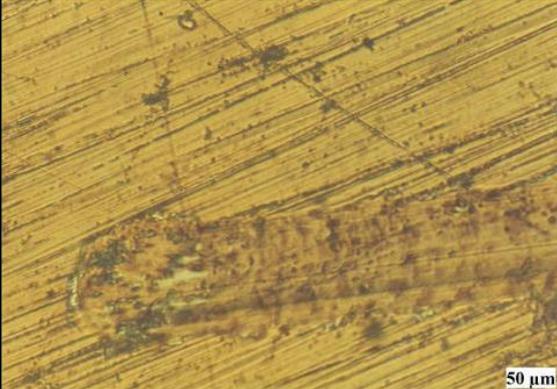
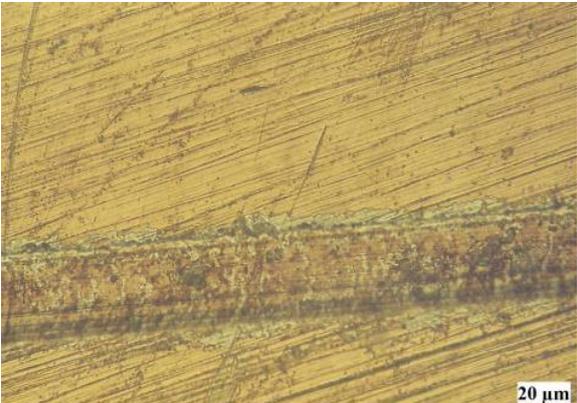
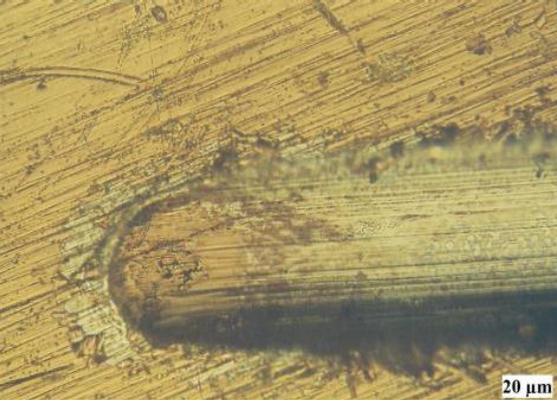
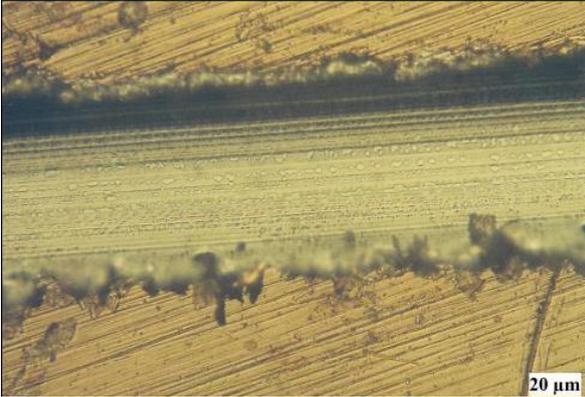
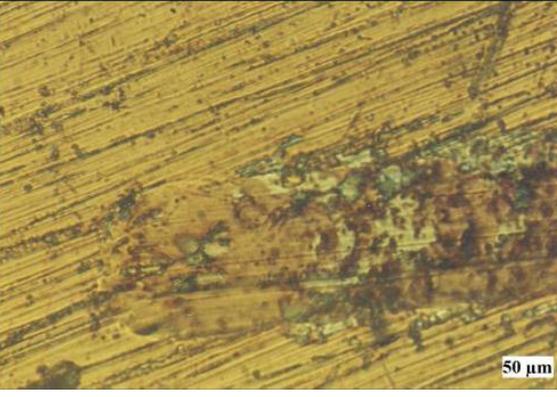
Table 5. Microscopic images of the main critical events appeared after scratch tests on the surfaces of 10000 pulses sample.

<p>10000 pls; 25 x 8= 200 x; F = 2.5 N; Trace 1: Start Material deformation and detachment (critical event Ec 1) to the point of reaching the indenter's tip when starts</p>	<p>5000 pls; 20 x 25= 500 x; F = 2.5 N; Trace 1: Final Detached fragments of the coating (critical event Ec 2)</p>

<p>10000 pls; 20 x 8= 200 x; F = 10 N; Trace 3: Pathway Semicircular crack (critical event Ec 3)</p>	<p>10000 pls; 25 x 8= 300 x; F =40 N; Trace 5: Start Raising material on the edges starts (critical event Ec 4)</p>

<p>10000 pls; 25 x 8= 200 x; F = 40 N; Trace 5: Pathway Chipping the base material starts (critical event Ec 5)</p>	<p>10000 pls; 25 x 20= 500 x; F = 5 N; Trace 2: Start Oxidation traces (critical event Ec 6)</p>

In Table 4 is the information about the main features of scratches made on the surface of TiN coating deposited with 10000 pulses after the scratch test. It is about critical events that occur in certain moment of critical forces action, with values of 2.5 N, 5 N, 10 N, 20 N and 80 N. Microscopic images of the traces occurred after the scratch tests performed are presented in Table 5.

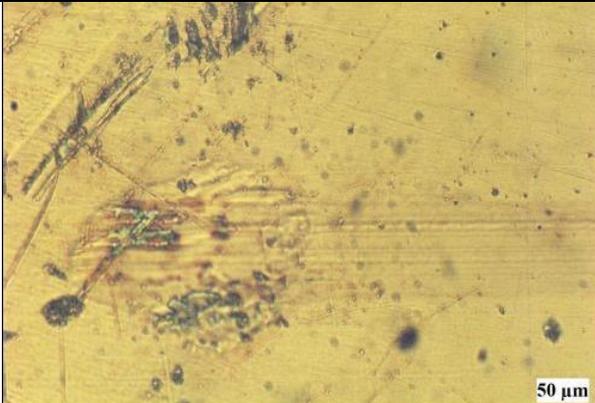
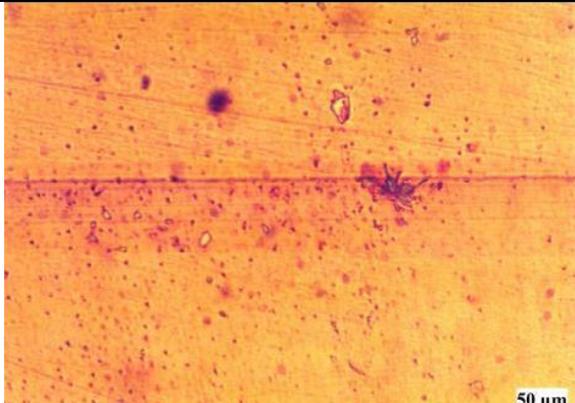
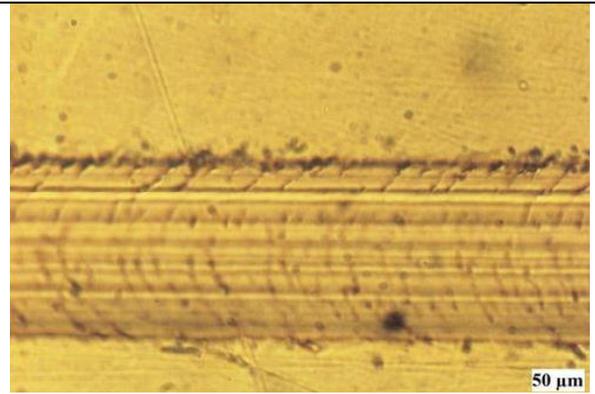
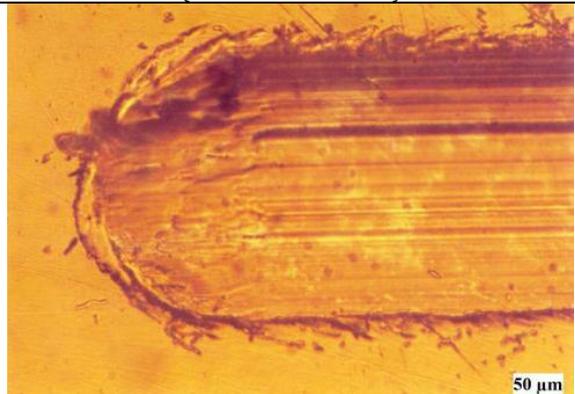
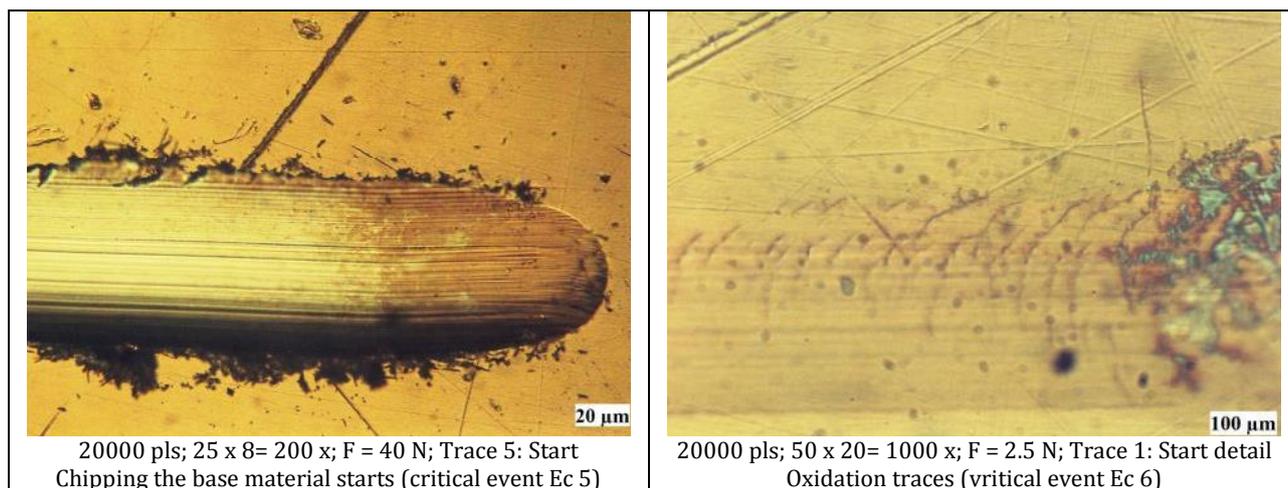
Table 7. Microscopic images of the main critical events appeared after scratch tests on the surfaces of 20000 pukes sample.

<p>20000 pls; 25 x 20= 500 x; F = 2.5 N; Trace 1: Final Material initial deformation and detachment (critical event Ec 1)</p>	<p>20000 pls; 25 x 20= 500 x; F = 2.5 N; Trace 1: Final Detached fragments of the coating (critical event Ec 2)</p>

<p>20000 pls; 25 x 20= 500 x; F = 10 N; Trace 3: Pathway, Semicircular crack (critical event Ec 3)</p>	<p>20000 pls; 25 x 20= 500 x; F =20 N; Trace 4: Final Raising material on the edges starts (critical event Ec 4)</p>

moments of critical forces action, with values of 2.5 N, 5 N, 10 N, 20 N, 40 N, 80 N and 125 N. Microscopic images of the traces occurred after the scratch tests performed are presented in Table 7.

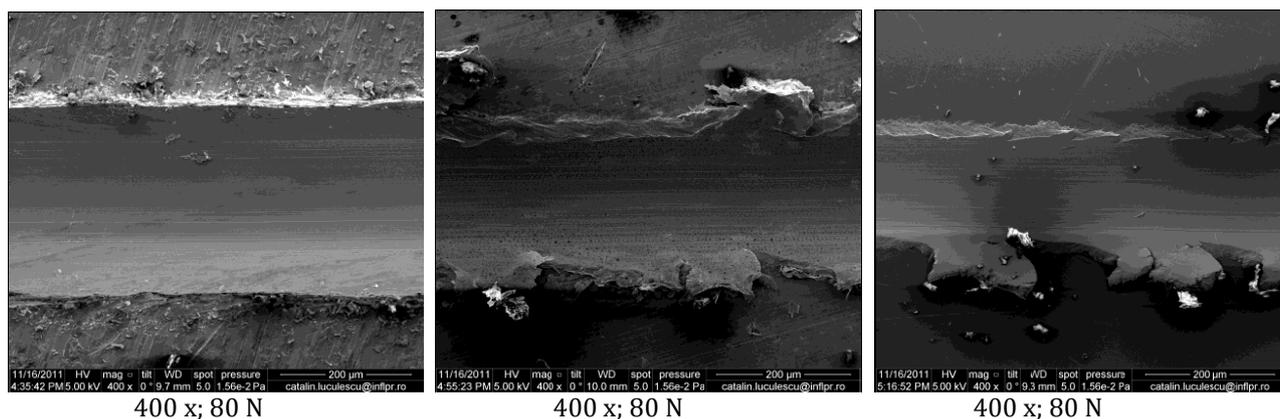
Fig. 6. SEM images of the surfaces of TiN layers deposited at 5000, 10000 and 20000 pulses after the scratch test with 80 N (magnification 400x).

For a more accurate characterization of surfaces of TiN thin films subjected to scratch tests were also performed their SEM investigations. An example is shown in Fig. 6, where it can be seen that the same amount of force, the surface of TiN is harder with increasing number of pulses used at deposition.

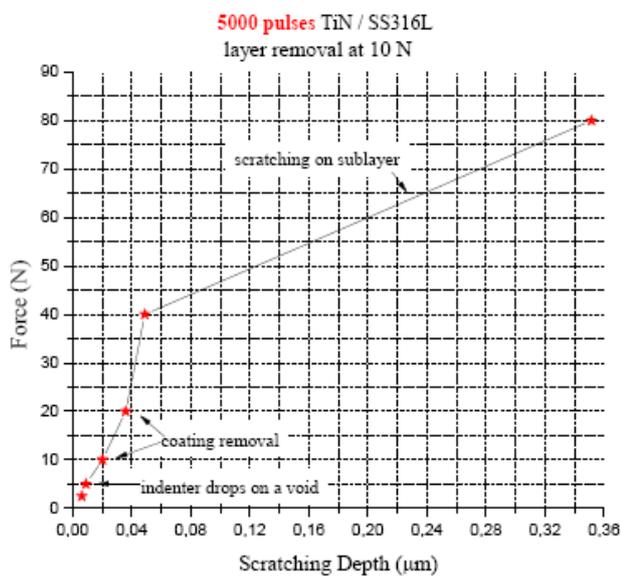
Fig. 7. Force - depth diagram for deposited layer at 5000 pulses.

Graphic variation curves of scratch depth depending on the applied normal load were drawn considering the depth of obtained scratches (Figs. 7-9). These curves show some drops due to various defects of the coating.

It can be seen from these images that at a certain value, the layer is removed during the scratch test. The force applied whereat the deposited layer is removed from the substrate defines the critical force (load) (Fc). This is influenced by many factors, like substrate hardness, film thickness, interface contact and the intrinsic properties of the deposited film.

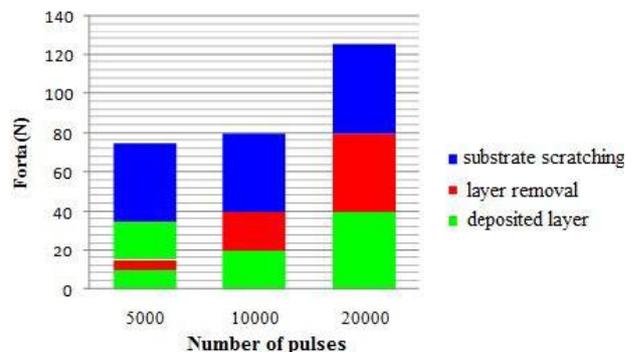
Fig. 10. Comparative force - number of pulses diagram of the three layers applied.

Figure 10 presents a comparative diagram between the three deposited layers. One can easily observe that the films deposited with 5000 pulses and 10000 pulses cannot support a force greater than 80 N.

The layer deposited at 20000 pulses can also resist when on its surface a force of 125 N is applied during the scratching test. Force

whereat deposited layer removing begins increases with the number of pulses that is used to deposit the layer: 10 N for the sample with the layer deposited at 5000 pulses, 20 N for the sample with the layer deposited at 10000 pulses and 40 N for the sample with the layer deposited at 20000 pulses. Layer removal is accomplished within an increasingly larger range, for the 5000 pulses sample being necessary to apply a force of 10 N and increase with only 10 N to complete the removal. For 10000 pulses sample the substrate removal starts when a 20 N force is applied, and an increase of 20 N determines the completion of this process. A force of 40 N with an increase of another 40 N can remove the layer from the sample of 20000 pulses.

An important conclusion that can be drawn from these observations is that the layer deposited at 20000 pulses is stronger, more adherent to the substrate and more uniformly deposited than the other two samples.
